Advances in Hydroinformatics

Chapter 36

The 1915 Mud-Debris Flow at San Fruttuoso Di Camogli: Modeling the Collapse Effects in the Portofino Pilot Area of the H2020 Reconnect Project

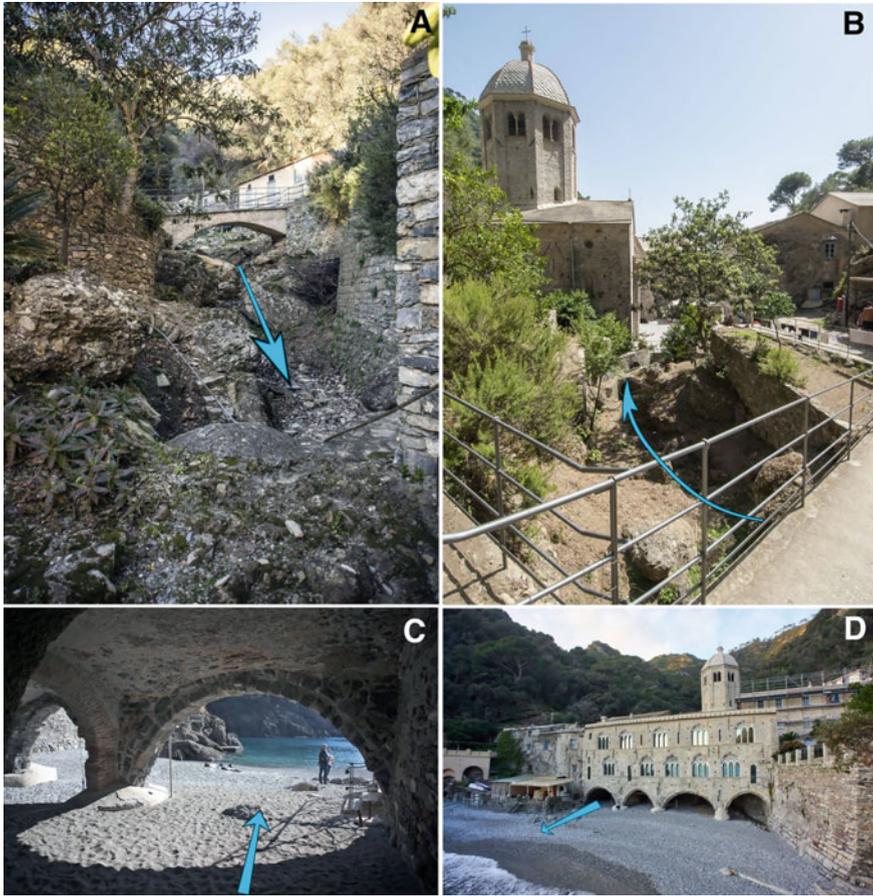
Fig. 36.3 **a** The stream approaching the culvert running beneath the Abbey; **b** the culvert inlet; **c** the culvert outlet the beach; **d** view of the Abbey with the culvert outlet

Inside the park there are important historical and architectural testimonies, recognizable along its footpaths. At the mouth of the Valle dei Fontanini catchment the Medieval San Fruttuoso Abbey (Fig. 36.3) lies transversally on the stream.

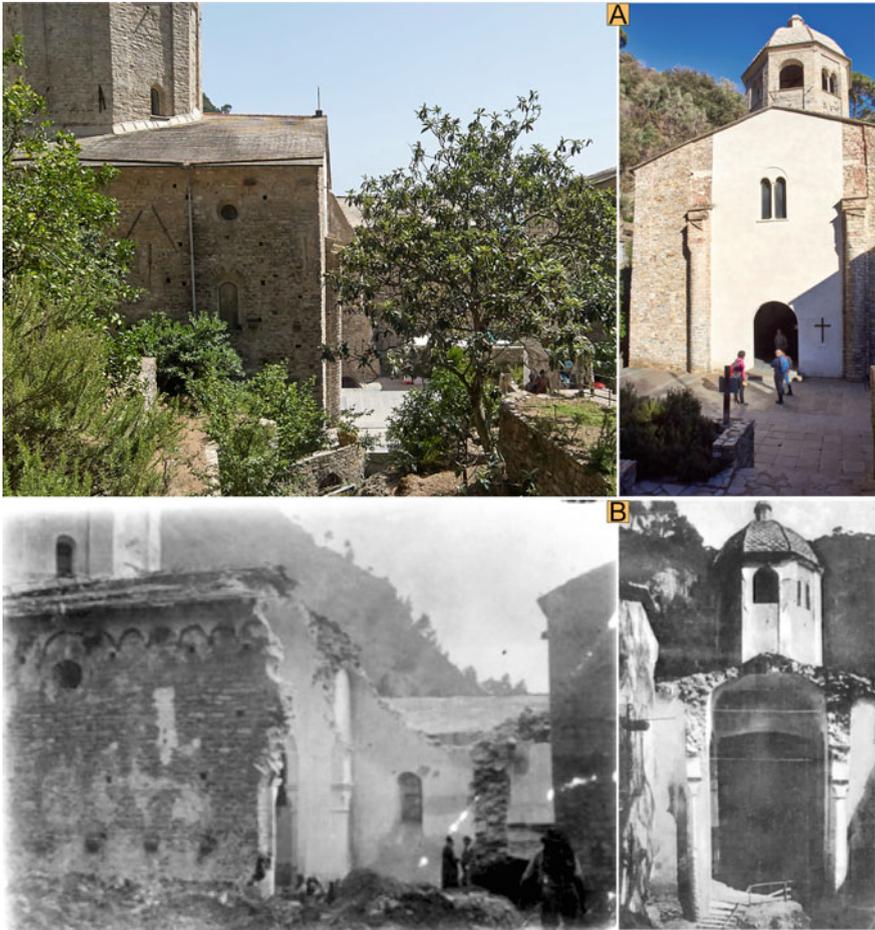
Fig. 36.4 A) The actual status after the recovery comparing to the partially collapsed Abbey after the 1915 event B)

Figure 36.4 shows a comparison between the damaged Abbey and its current condition: the partial collapse is clearly visible and involved the church façade and part of the building that laid upon the culvert: its lower part was demolished. In Fig. 36.5 a comparison between the beach before the event and its current status are shown. The beach persisted as the result of the accumulaton of debris and sediments.

The total volume of the moving mass has been estimated in about 6200 m^3 . Even if it is not a large quantity, it would be able to cause the collapse of large portion of the Abbey: both the church façade and part of the building laying on the culvert (Fig. 36.4b).

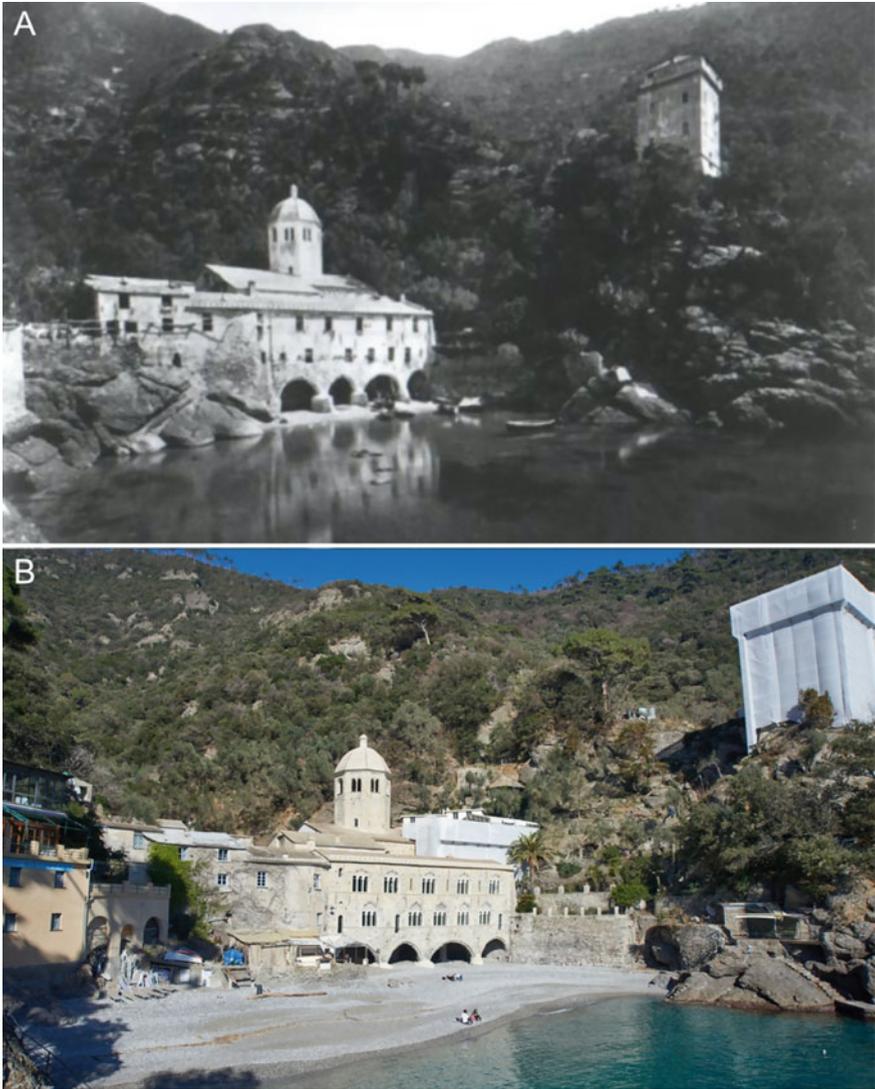
Fig. 36.5 The San Fruttuoso bay before 1915 (a) and actual (b): the beach appeared after the 1915 event

As a second step, we examined the more favorable slope gradient and aspect conditions and identified a possible source area for the debris and sediments that damaged the Abbey in 1915. We postulated that the source had medium thickness of about 1 m, its surface extent related to the volume of the accumulated debris on the beach. Considering the debris evidence [44], the accumulated volume can be estimated at about 6000–7000 m³. The bay configuration (Fig. 36.5) does not allow

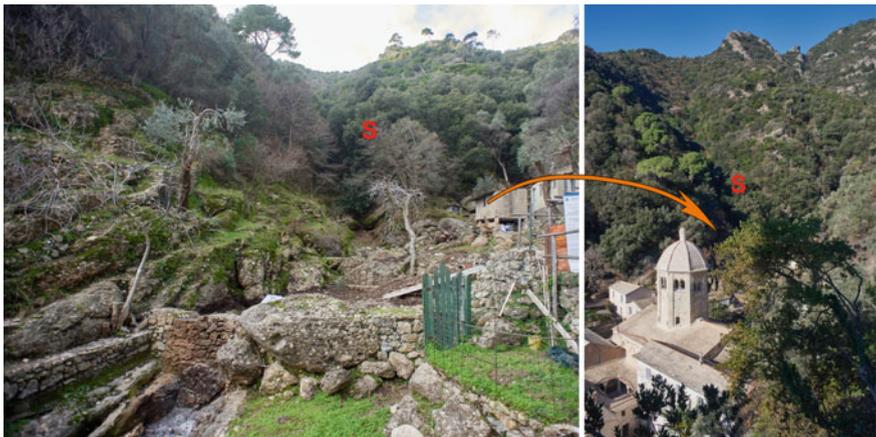
In Fig. 36.8 the possible source area is identified. The lack of ground evidences may be explained by the artificial accumulation of debris and sediment employed for building the terraces. They are man-made landforms [49] and after more than 100 years, no sign of scarps or erosion cuts were left after their washing away. Besides, due to the high slope gradient, terraces in the study area have been often constructed by putting stone walls directly on the bedrock and bringing soil and sediments to constitute the terraces [34, 50]. Then, the collapse would have left the original rocky surface only.

Fig. 36.8 The possible debris flow source area (S) along the Alluvione creek
