Procurement and Installation of Monitoring Equipment

Demonstrators A and B

Deliverable D3.2

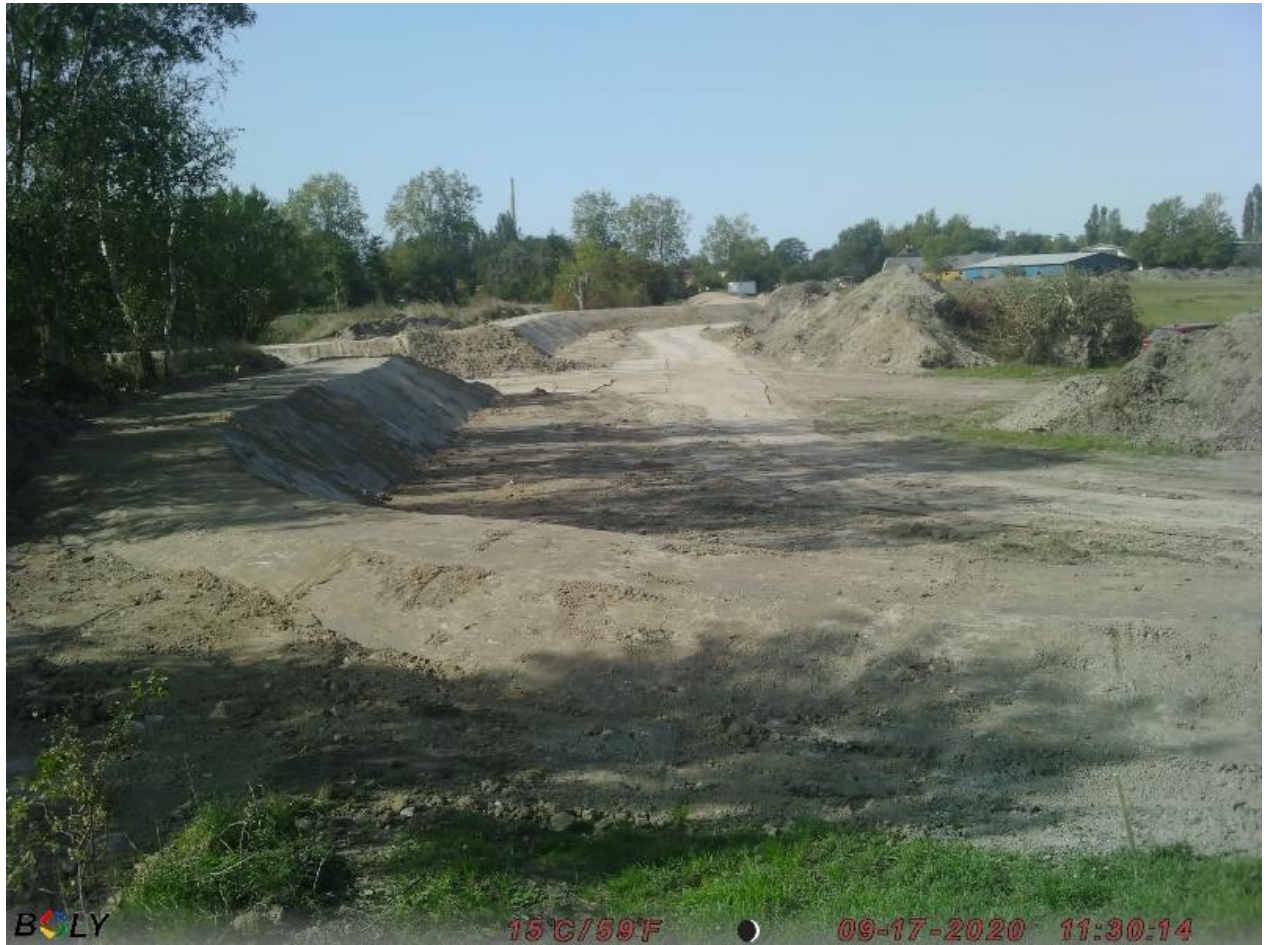
Figure 1: Picture from photo point from the beginning of construction.

Figures 1 and 2 are taken by the webcams purchased and installed to document the changes during construction works. The impacts of the removal of the dikes will be monitored by WATER, NATURE and PEOPLE indicators, such as changes in flood risk, habitat boundaries and recreational opportunities.

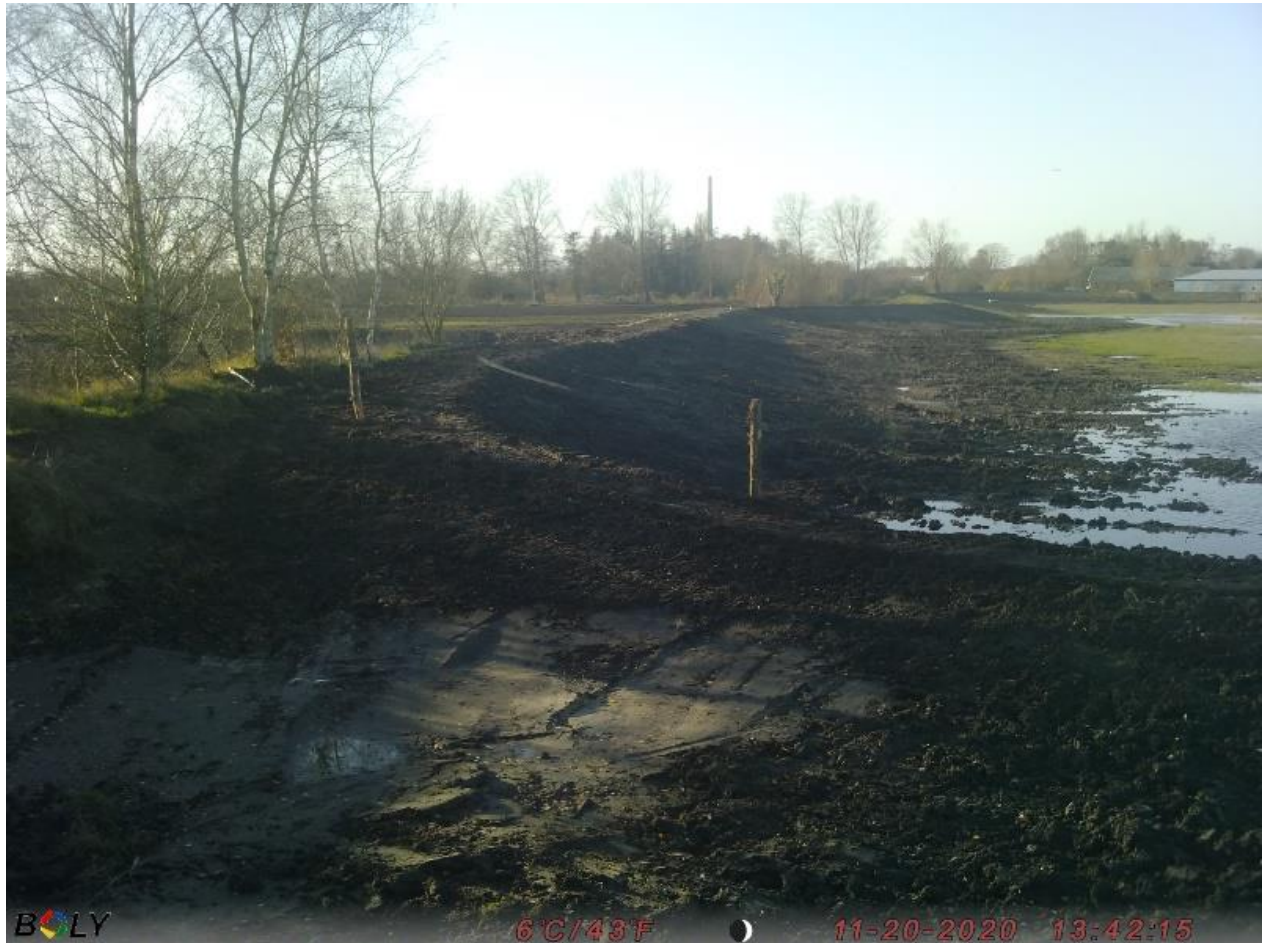
Figure 2: From the end of construction.

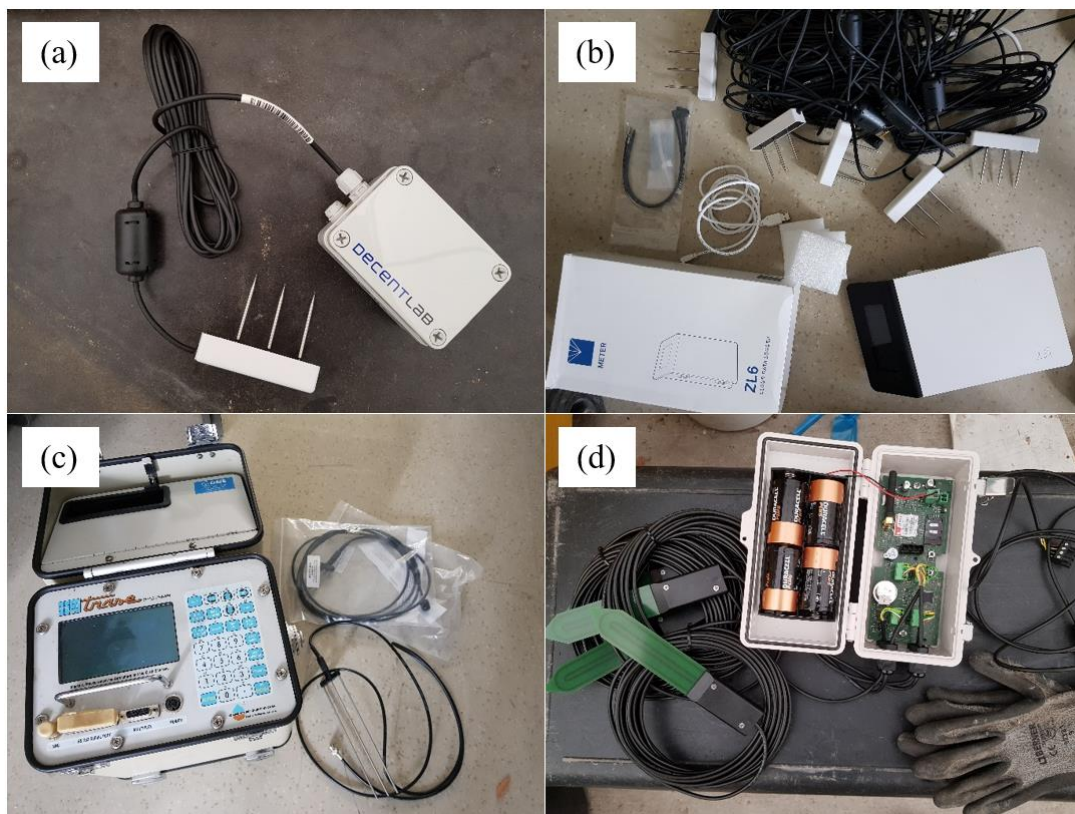
Figure 3: (a) TEROS-12 + Decentlab Datalogger + SENS (b) TEROS-11 + ZL6 Datalogger + ZENTRA Cloud (c) TDR (d) SMT100 + TrueLog100 Datalogger

As a first approach a lab test was carried out to test the different soil moisture sensors and dataloggers (Figure 1). Results of this test supported in decision making what type of soil moisture sensors were most suitable to purchase. It was found to use the SMT100 on locations where a large quantity of measurement points is required and the best option to install in the rainfall runoff plots. These sensors have a good accuracy for the most affordable price. Furthermore, there is a lot of freedom in programming and to use smaller measurement intervals.

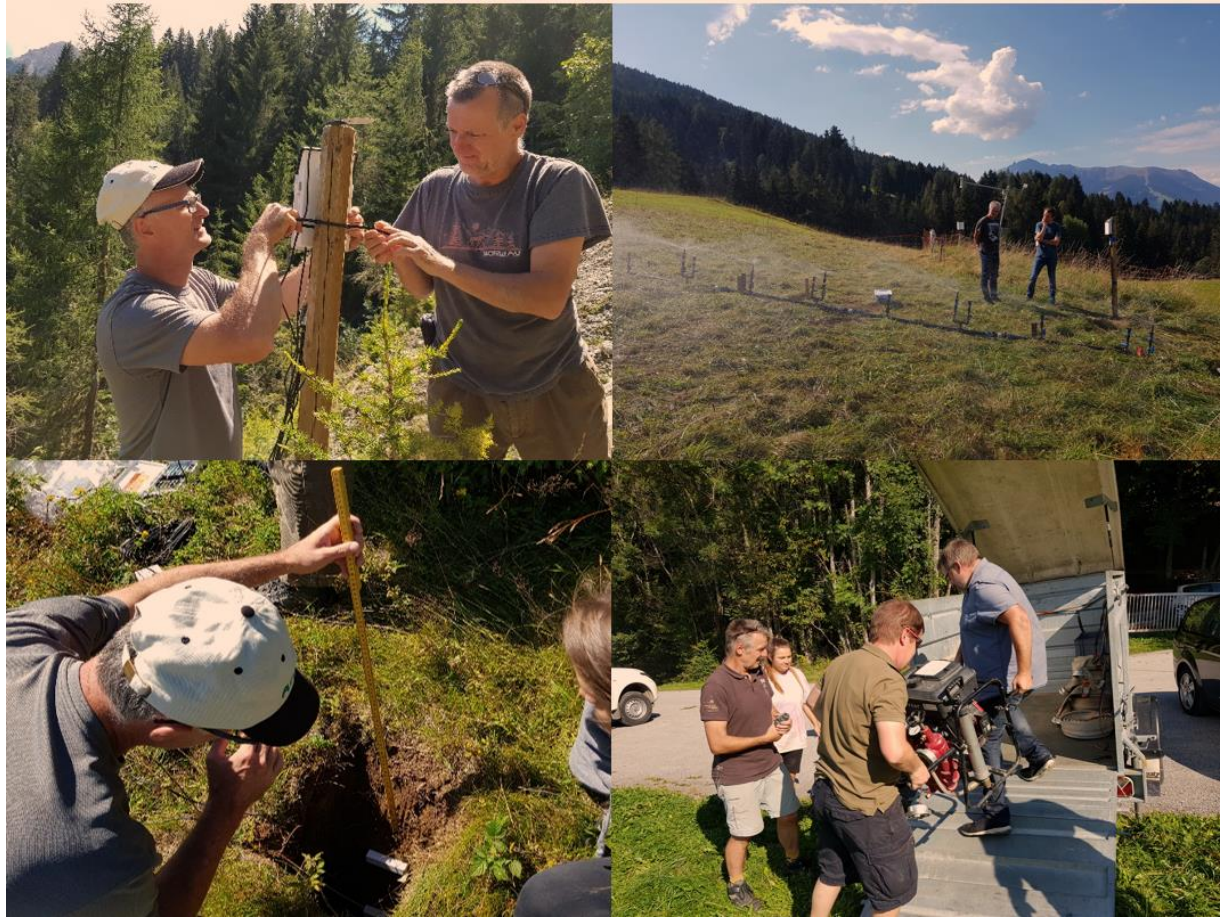
Figure 6: Installation of equipment in the field together with subcontractor BFW (Austrian Research Centre for Forests). The left two pictures are made of the installation of soil moisture sensors on August 5, 2020. The right two pictures are taken at the artificial rainfall-runoff site during a National Workshop on September 16, 2020.

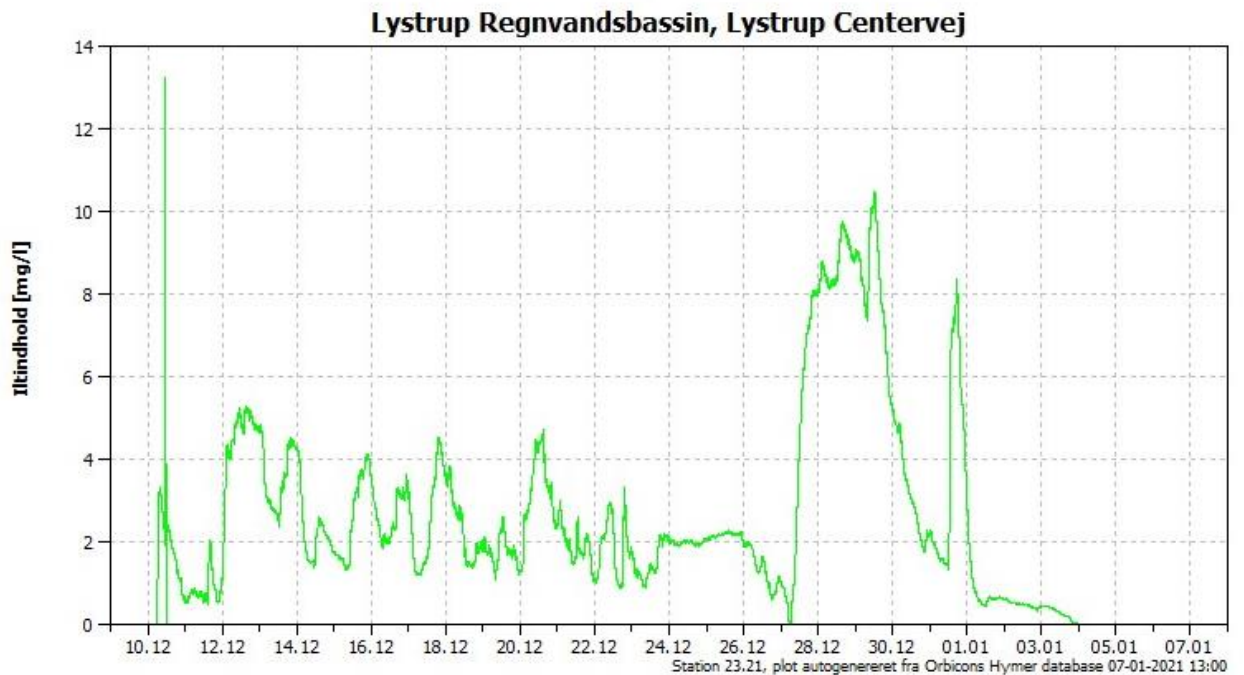
Figure 8: Example of oxygen concentration measurement at the outlet from the rainwater dam in Lystrup

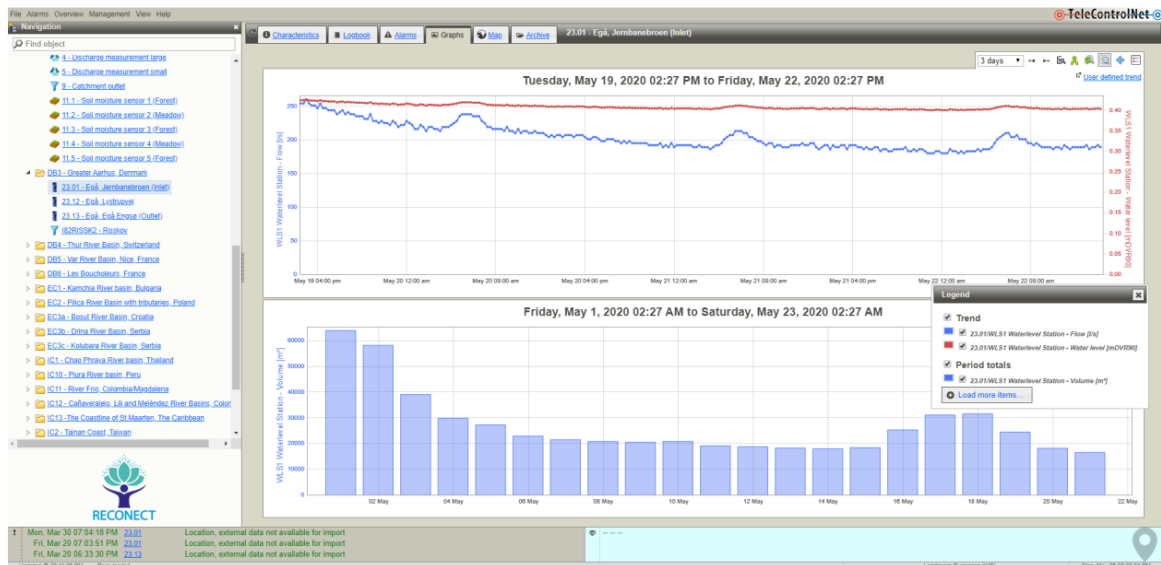
Figure 10: Example of monitoring data (water levels and retention volume) at Ega, Jernbanebroen (Inlet), Greater Aarhus, Denmark (DB3)

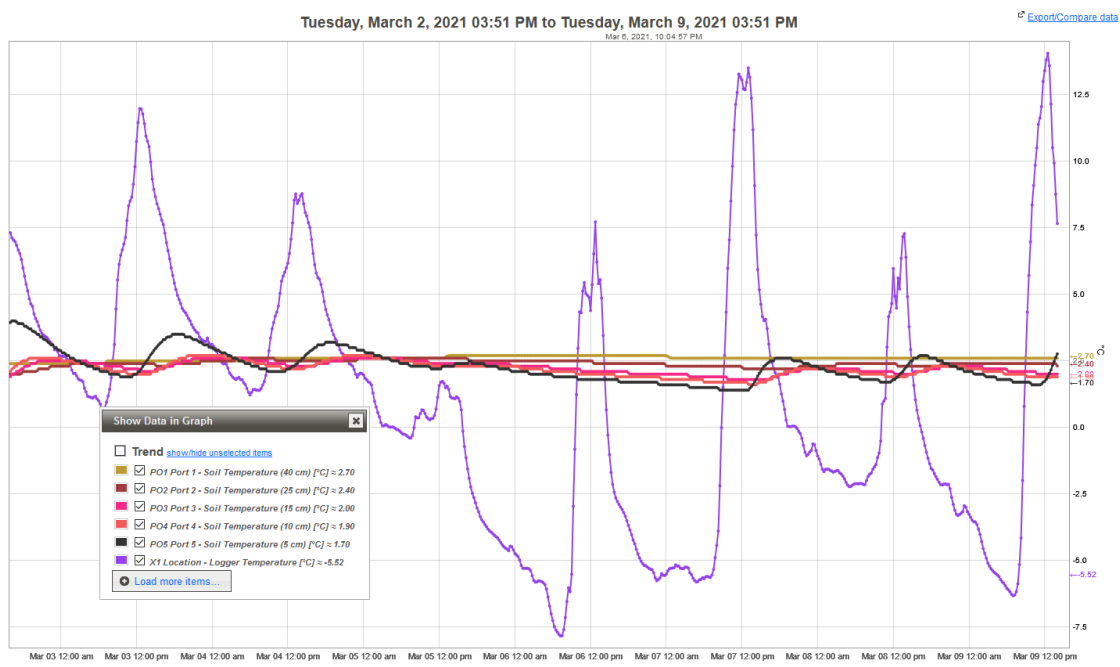
Figure 11: Graphs showing data transmitted to TeleControlNet in real time such as weather data from DA2 –Portofino Park and soil moisture from DB4- Thur River Basin
